# **GREAT DESIGNS IN STEEL**

## **AHSS REPAIRABILITY**

# PROJECT GOALS

An Auto/Steel Partnership Repairability Team Project

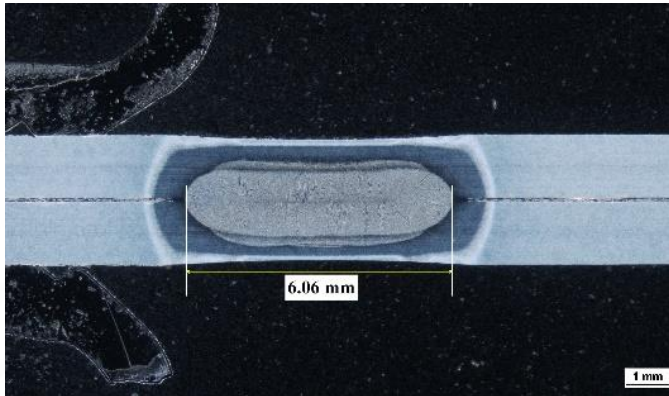
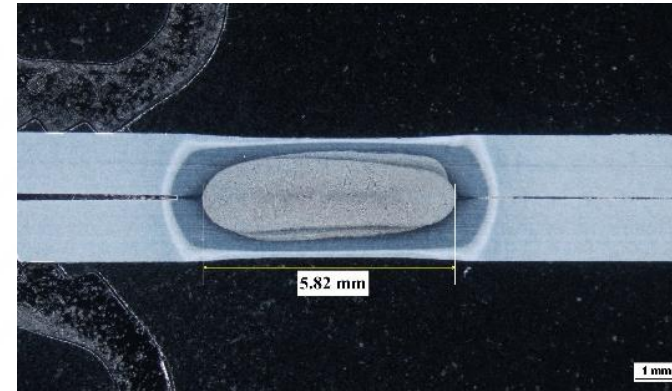
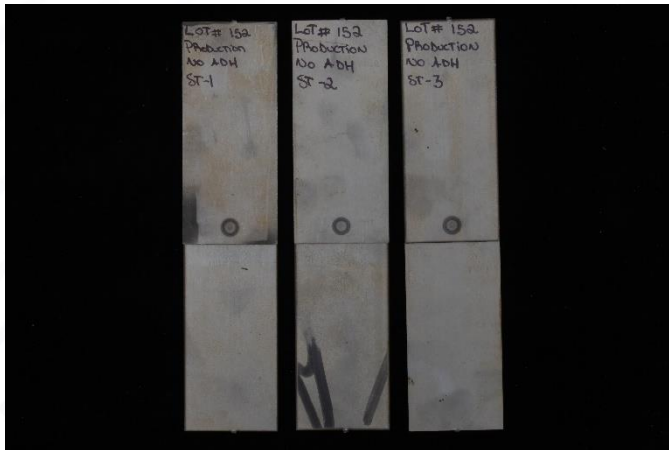
1.4 mm 3rd Gen 980 - uncoated (Lot#152): RSW (Production)

RSW  
(Production)

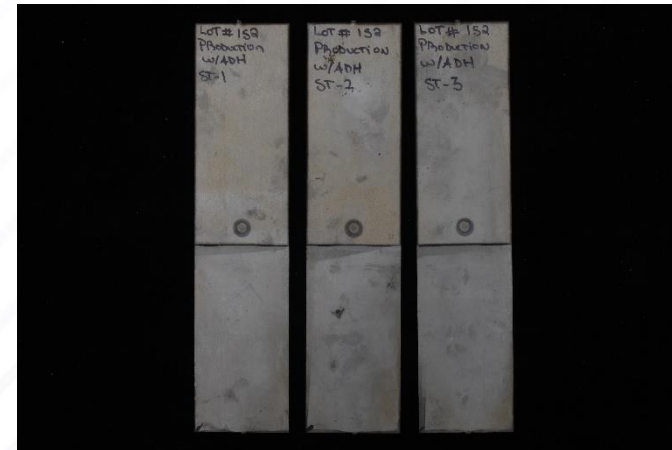
RSW (Production) with  
production adhesive

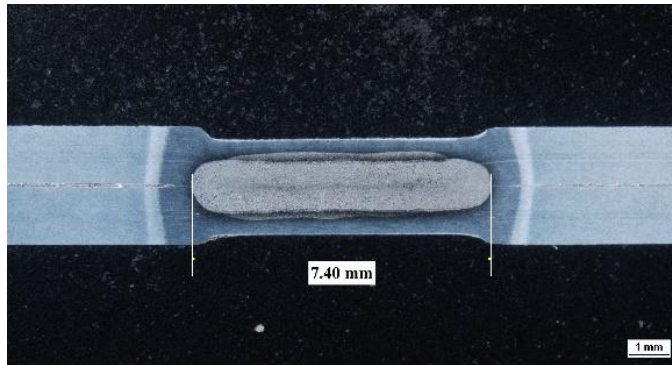
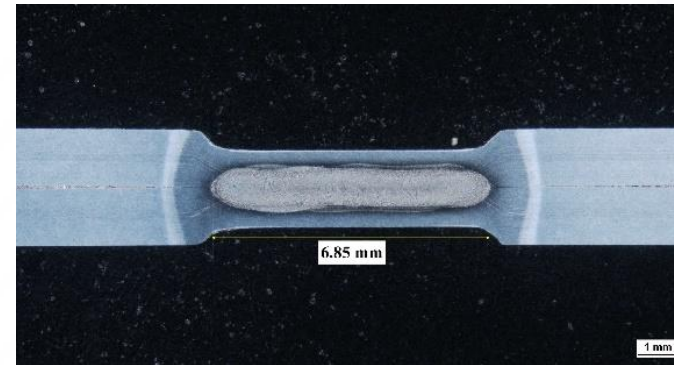
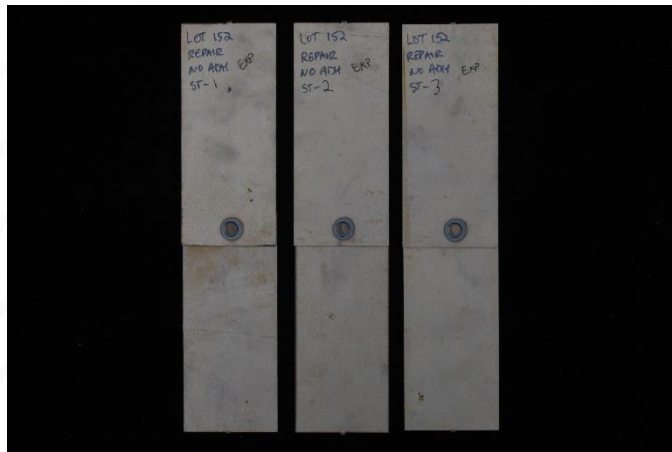
1.4 mm 3rd Gen 980 - uncoated (Lot#152): RSW (Service)

RSW  
(Service)

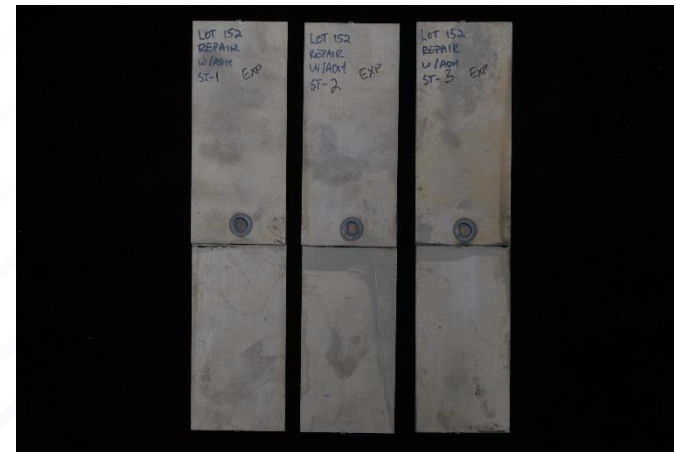
RSW (Service) with  
service adhesive

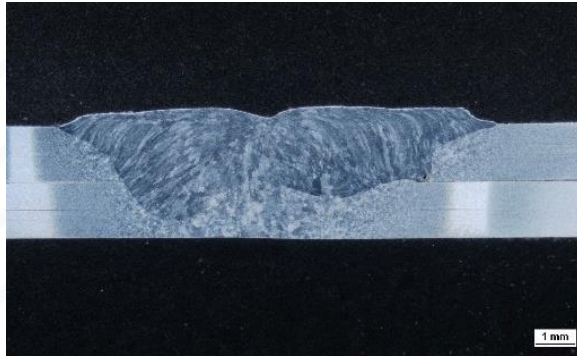
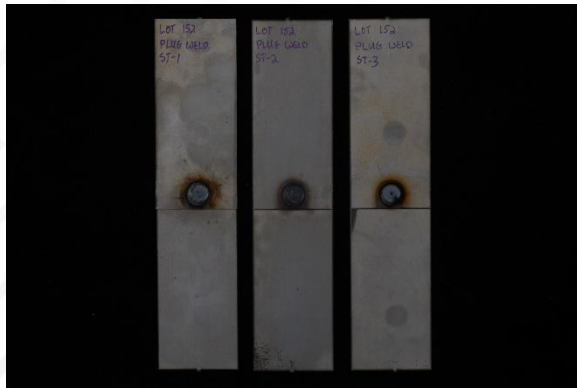
1.4 mm 3rd Gen 980 - uncoated (Lot#152): GMAW and GMAB

GMAW Plug

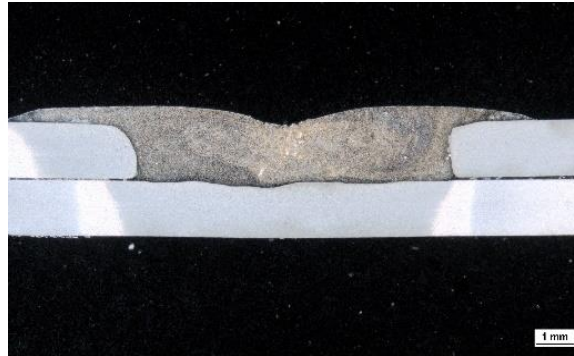
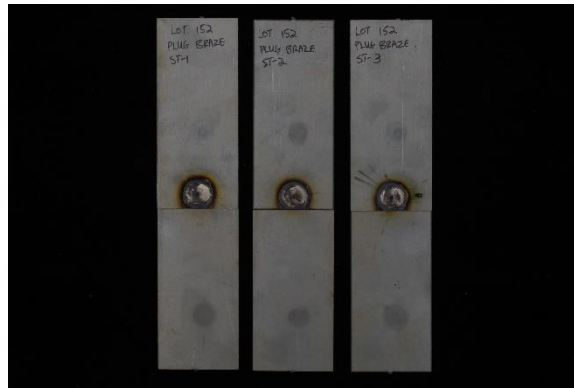
GMAB Plug

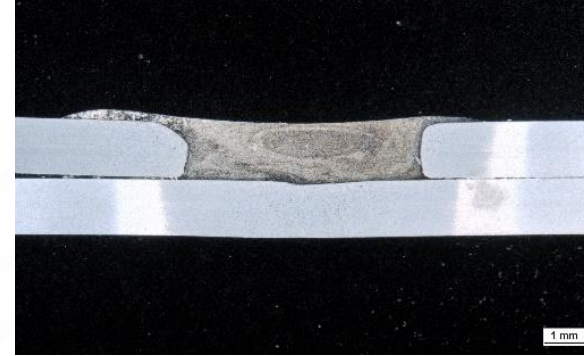
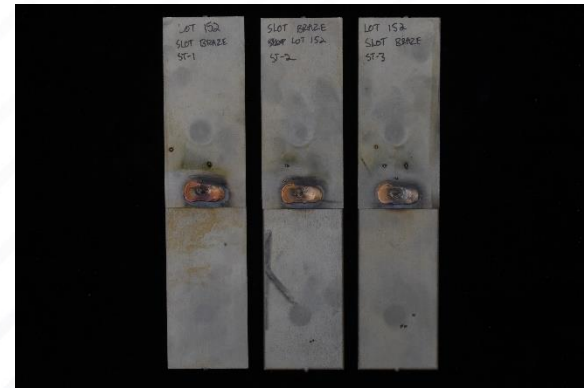
GMAB Slot

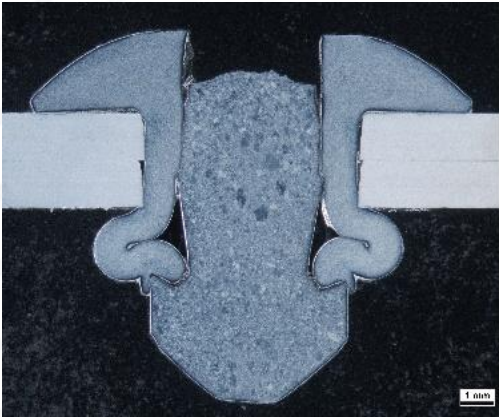
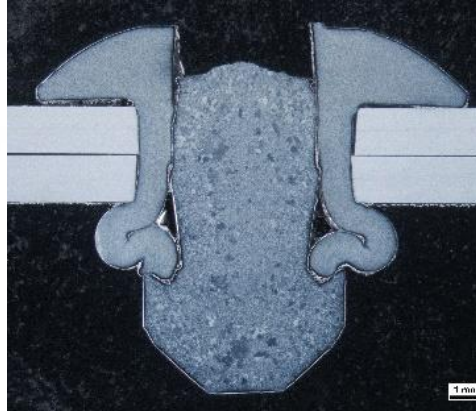
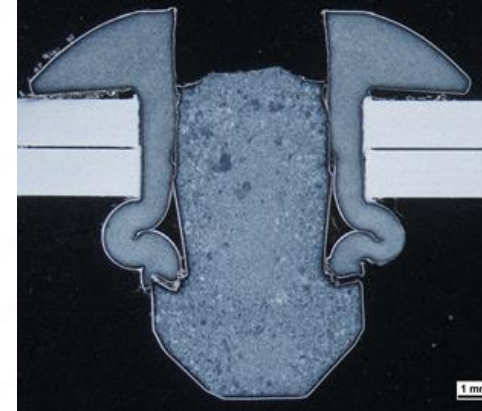
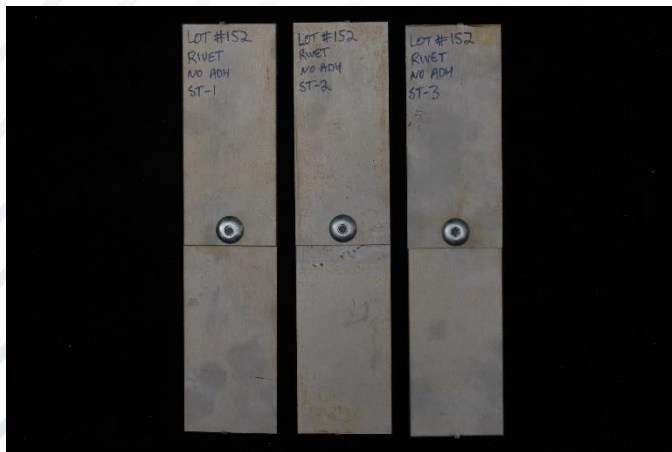
1.4 mm 3rd Gen 980 - uncoated (Lot#152): Hemlok Rivet

Hemlok Rivet

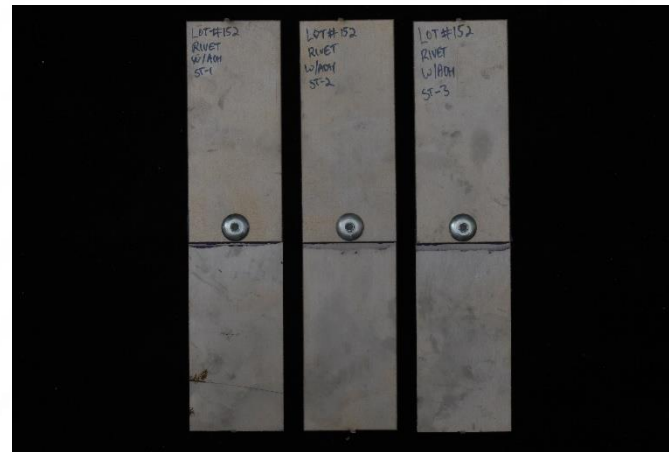
Hemlok Rivet with production adhesive

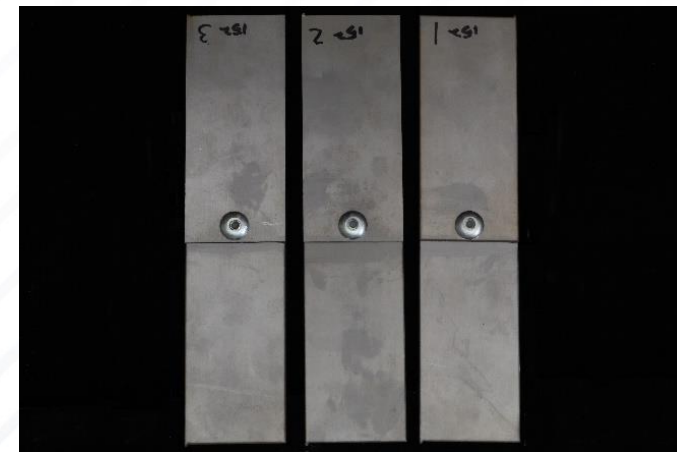
Hemlok Rivet with service adhesive

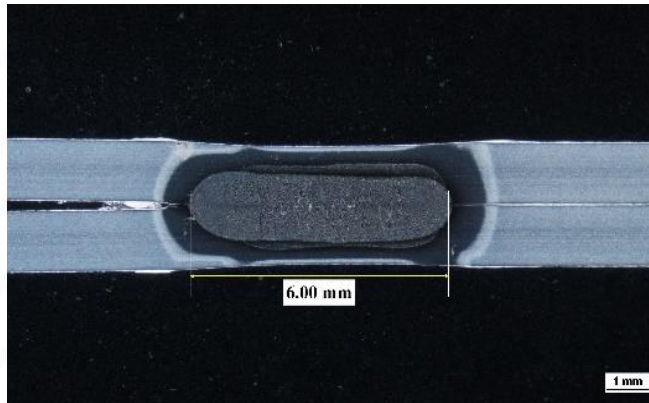
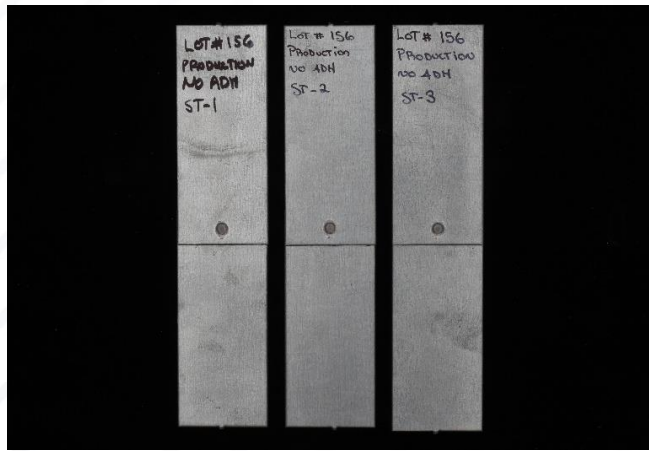
1.4 mm 3rd Gen 980 - HDGI (Lot#156): RSW (Production)

RSW (Production)

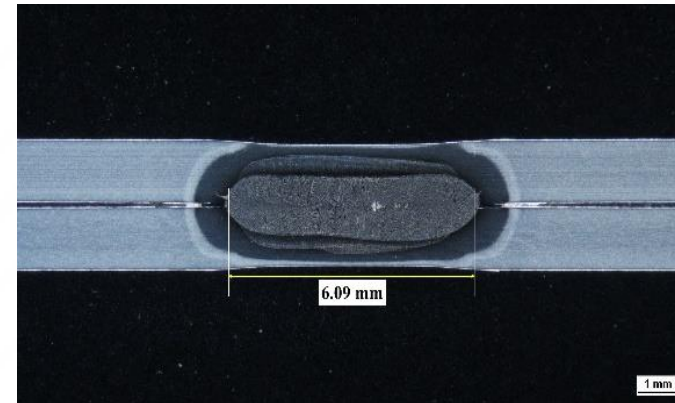
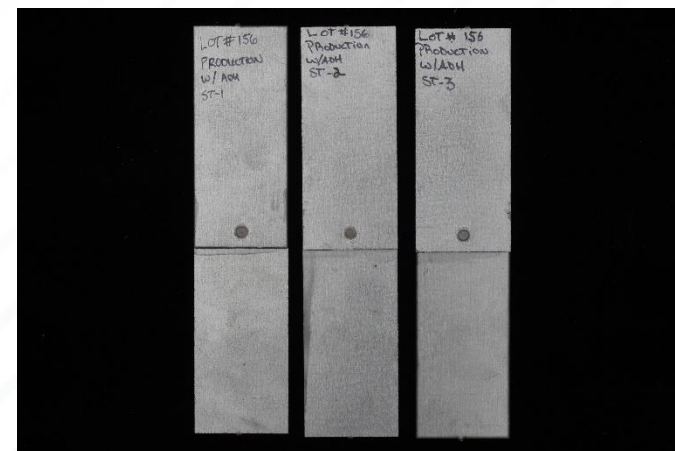
RSW (Production) with production adhesive

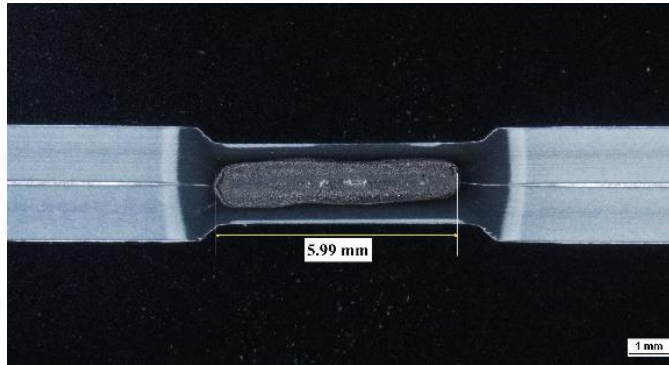
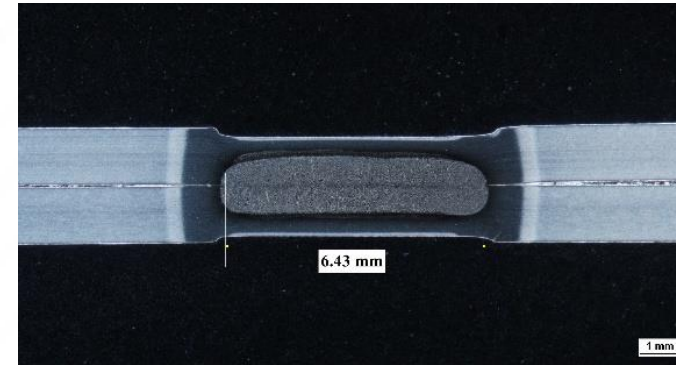
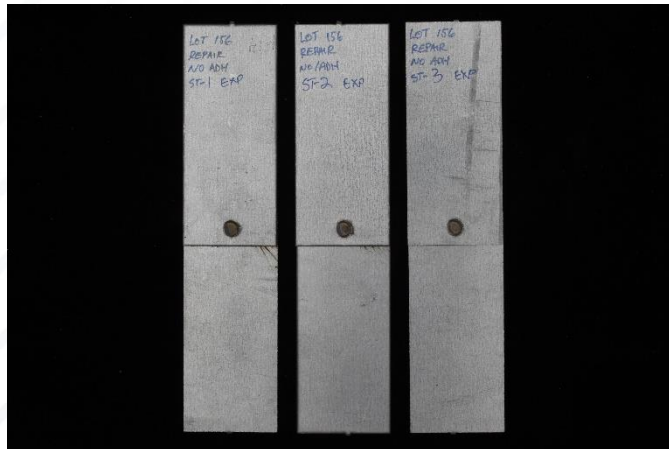
1.4 mm 3rd Gen 980 - HDGI (Lot#156) : RSW (Service)

RSW  
(Service)

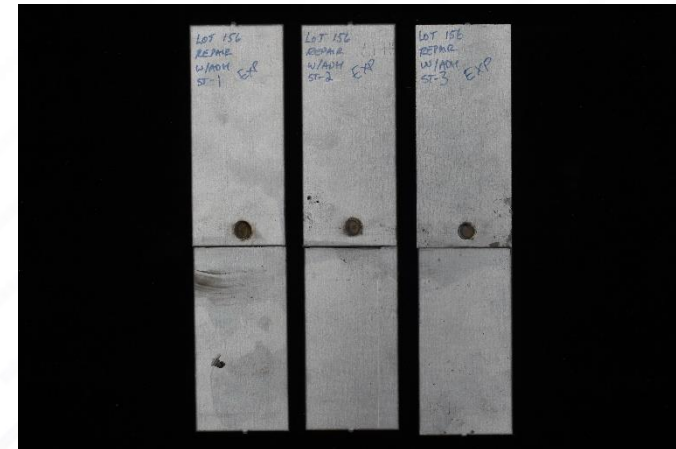
RSW (Service) with  
service adhesive

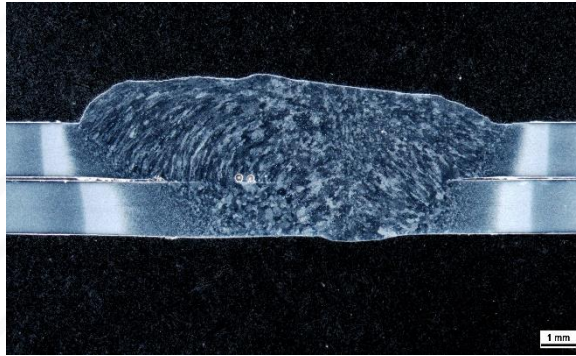
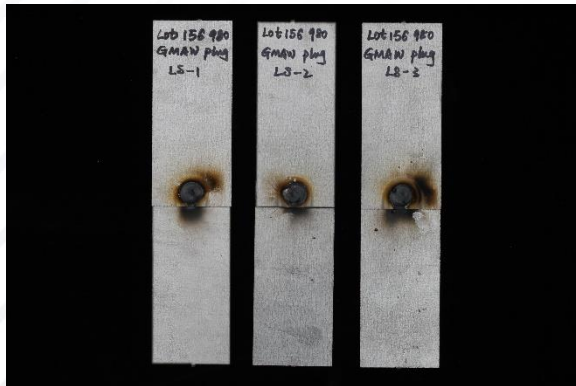
1.4 mm 3rd Gen 980 - HDGI (Lot#156) : GMAW and GMAB

GMAW Plug

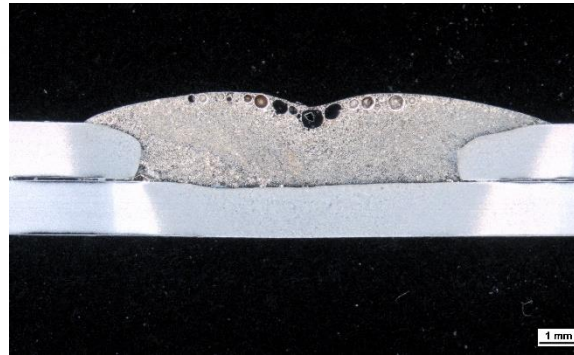
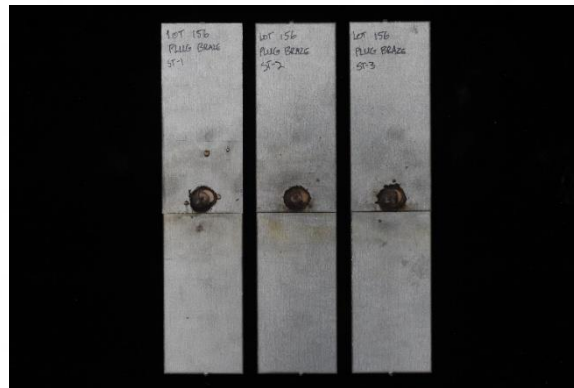
GMAB Plug

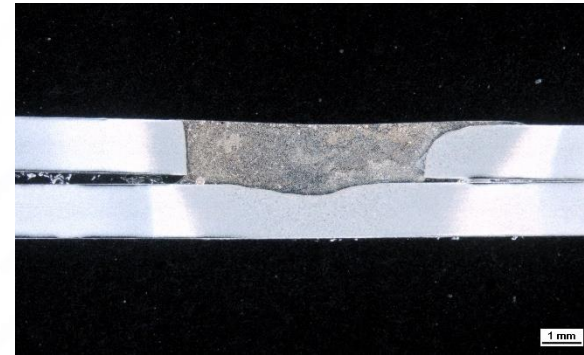
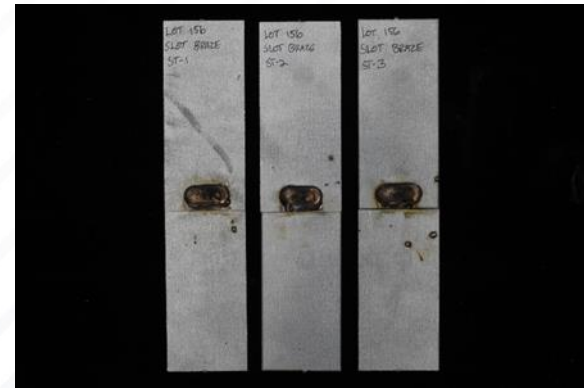
GMAB Slot

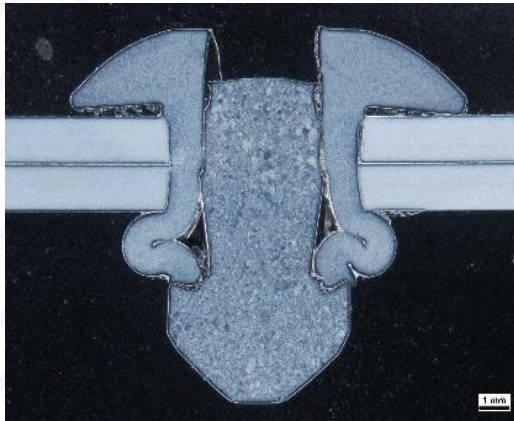
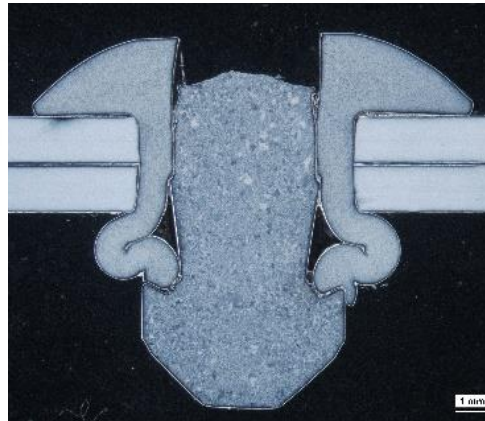
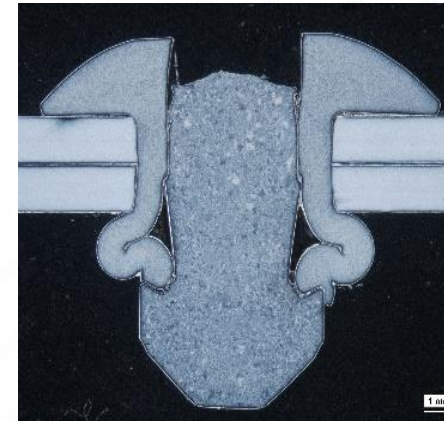
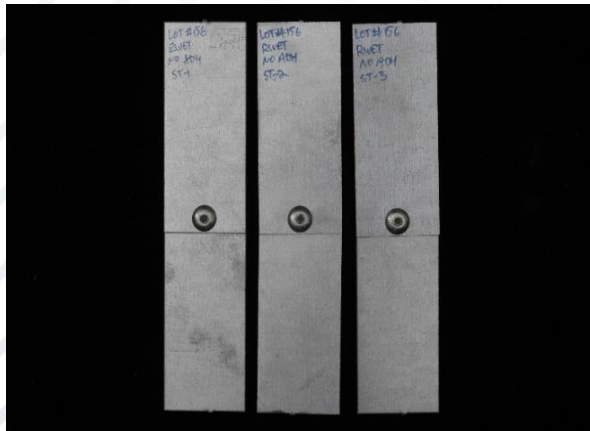
1.4 mm 3rd Gen 980 - HDGI (Lot#156): Hemlok Rivet

Hemlok Rivet

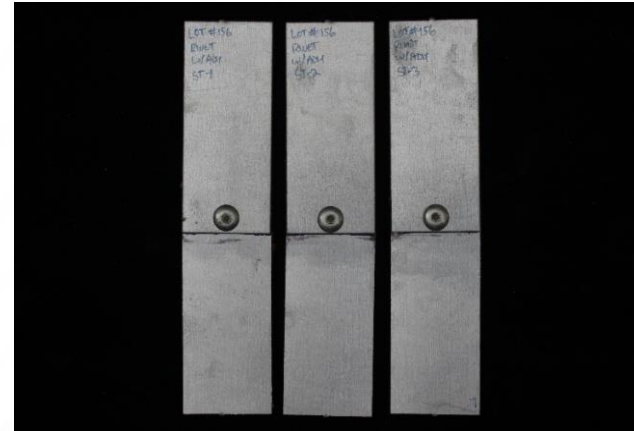
Hemlok Rivet with production adhesive

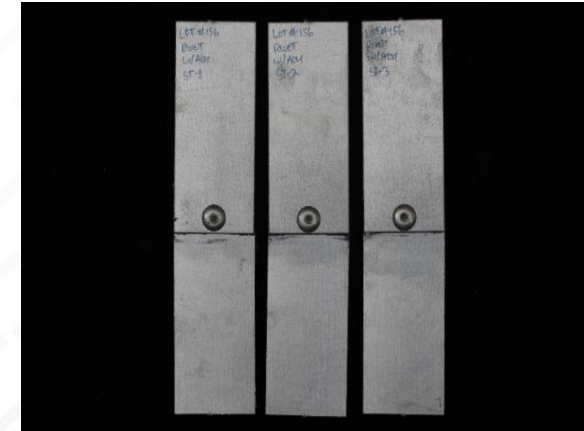
Hemlok Rivet with service adhesive

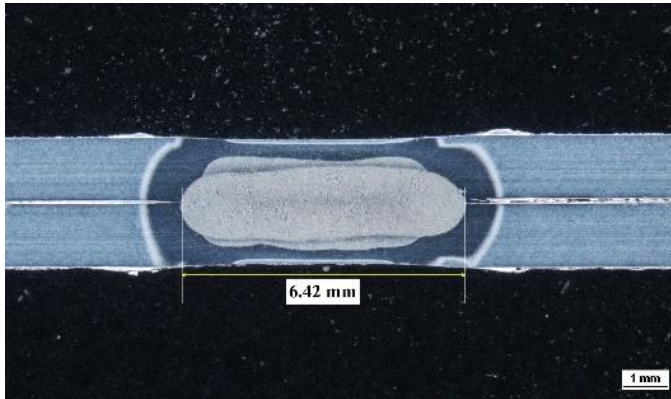
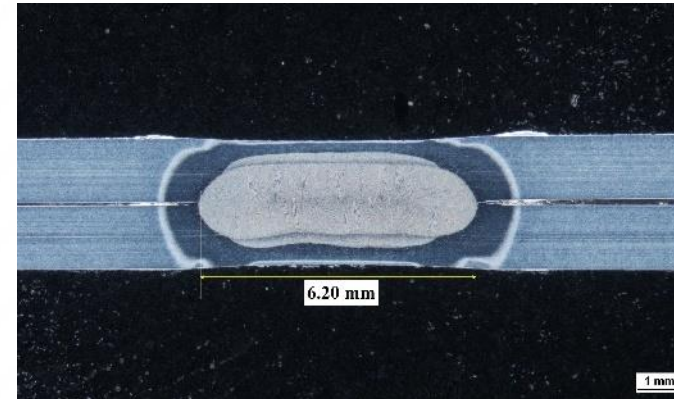
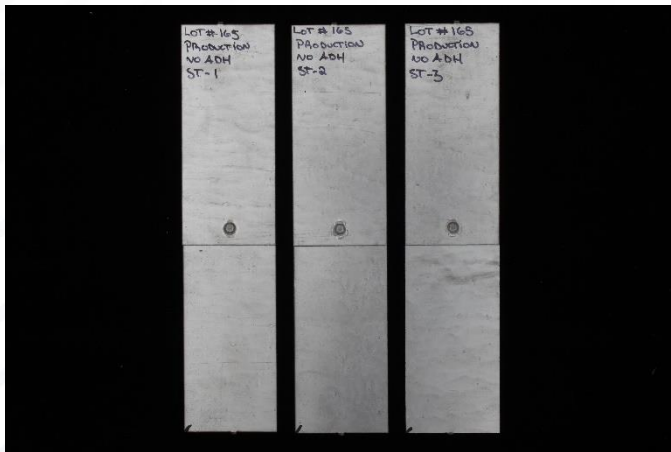
1.4 mm 3rd GEN 1180 - HDGI (Lot#165): RSW (Production)

RSW  
(Production)

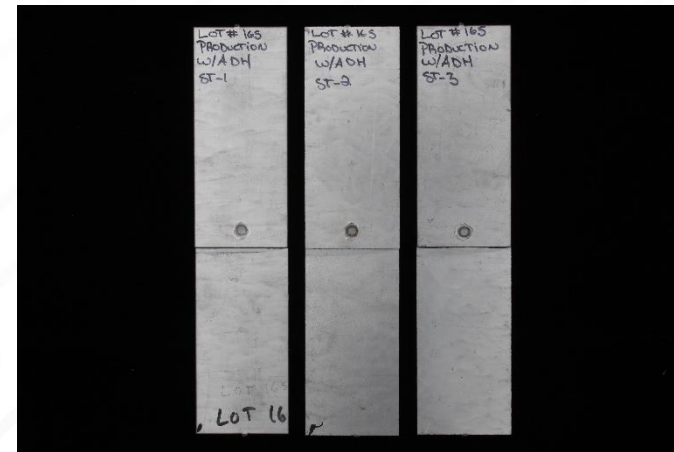
RSW (Production) with  
production adhesive

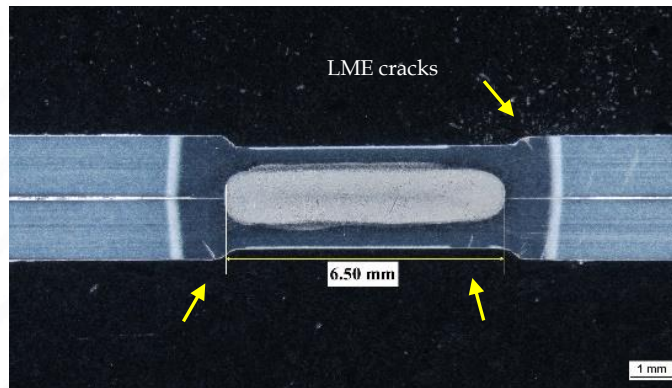
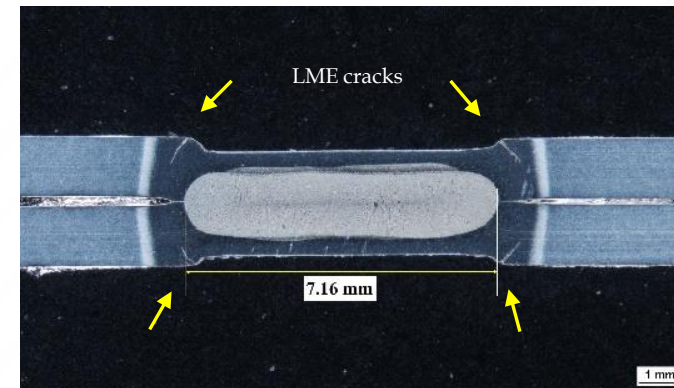
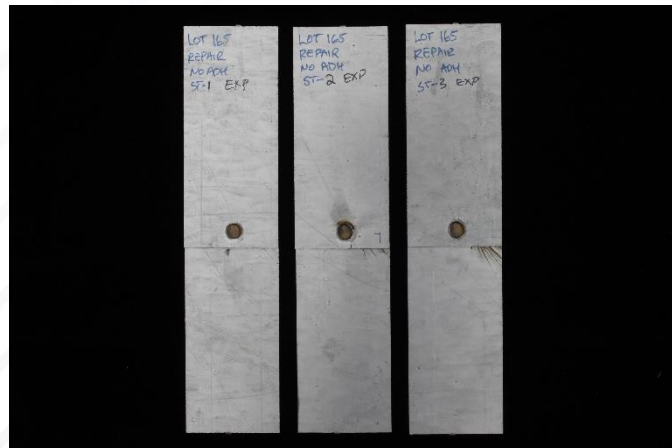
1.4 mm 3rd GEN 1180 - HDGI (Lot#165): RSW (Service)

RSW (Service)

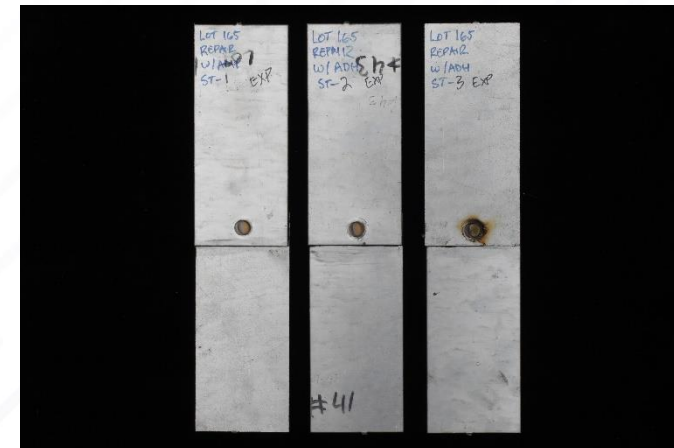
RSW (Service) with service adhesive

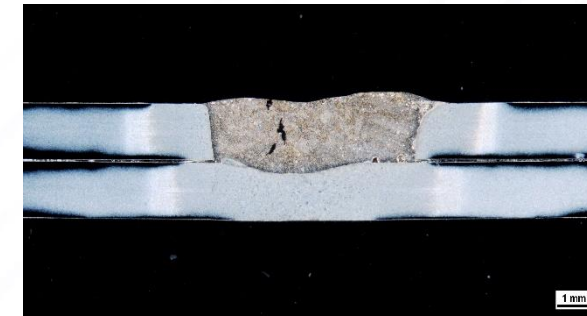
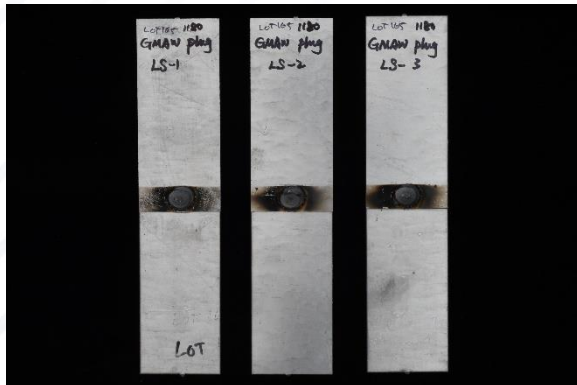
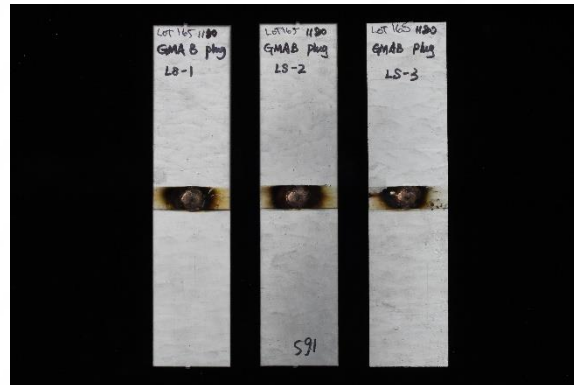
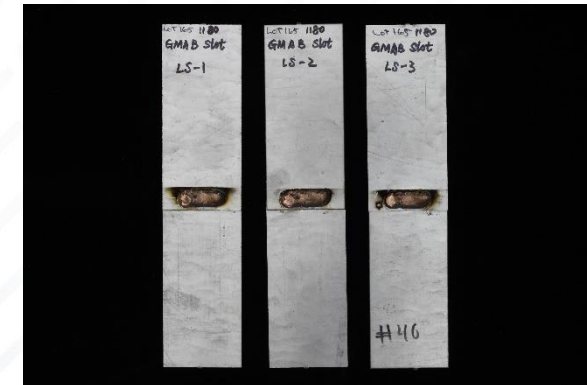
1.4 mm 3rd GEN 1180 - HDGI (Lot#165): RSW (Service)

GMAW Plug

GMAB Plug

GMAB Slot

- For materials evaluated in this project, appropriate repair methods can be selected
- Adhesive increased shear tension peak loads but had little effect on cross-tension peak loads
- Production adhesive joints had higher peak loads compared to service adhesive joints for both shear tension and cross tension
- LME cracking was observed in the 3rd GEN 1180 spot welds, both production and repair welder
- LME observed in the 3rd GEN 980 - HDGI service spot welds
- Significant LME cracking was observed in the GMAW plug and GMAB slot joint configurations:
  - 1.4 mm 3rd GEN 980 - HDGI (Lot#152) GMAW plug
  - 1.4 mm 3rd GEN 1180 - HDGI (Lot#165) GMAW plug, GMAB plug and GMAB slot

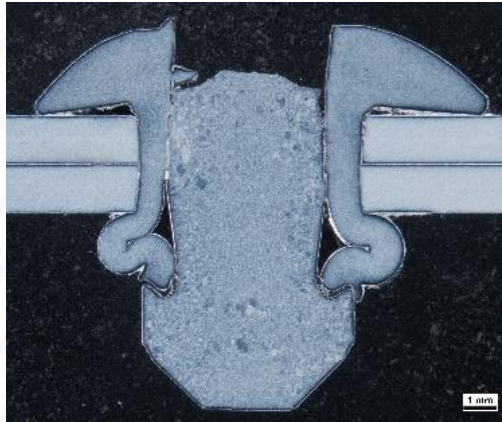
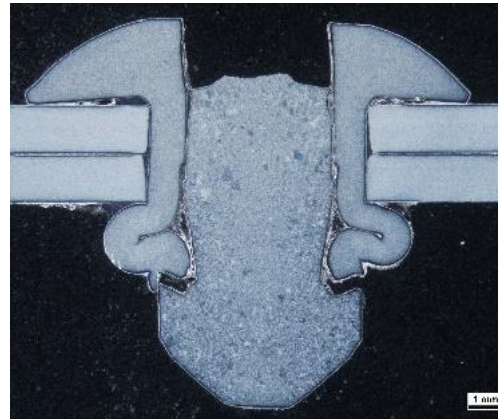
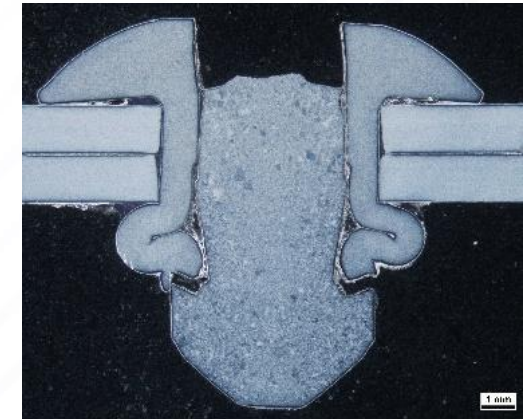
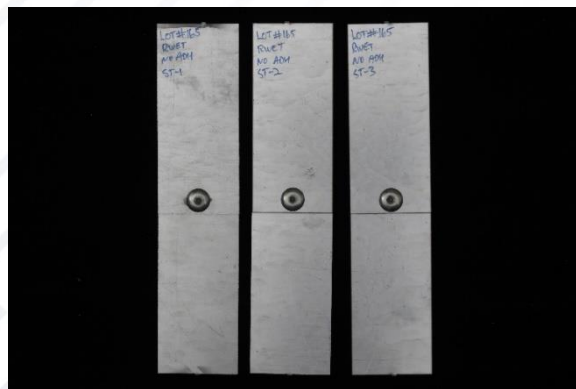
1.4 mm 3rd GEN 1180 - HDGI (Lot#165): Hemlok Rivet

Hemlok Rivet

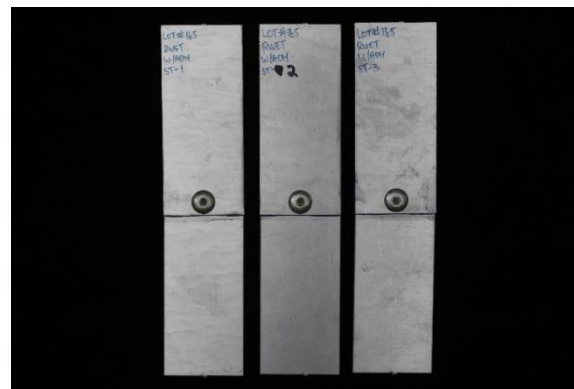
Hemlok Rivet with production adhesive

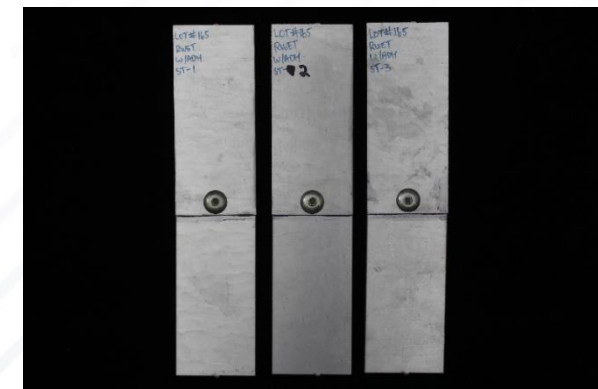
Hemlok Rivet with service adhesive

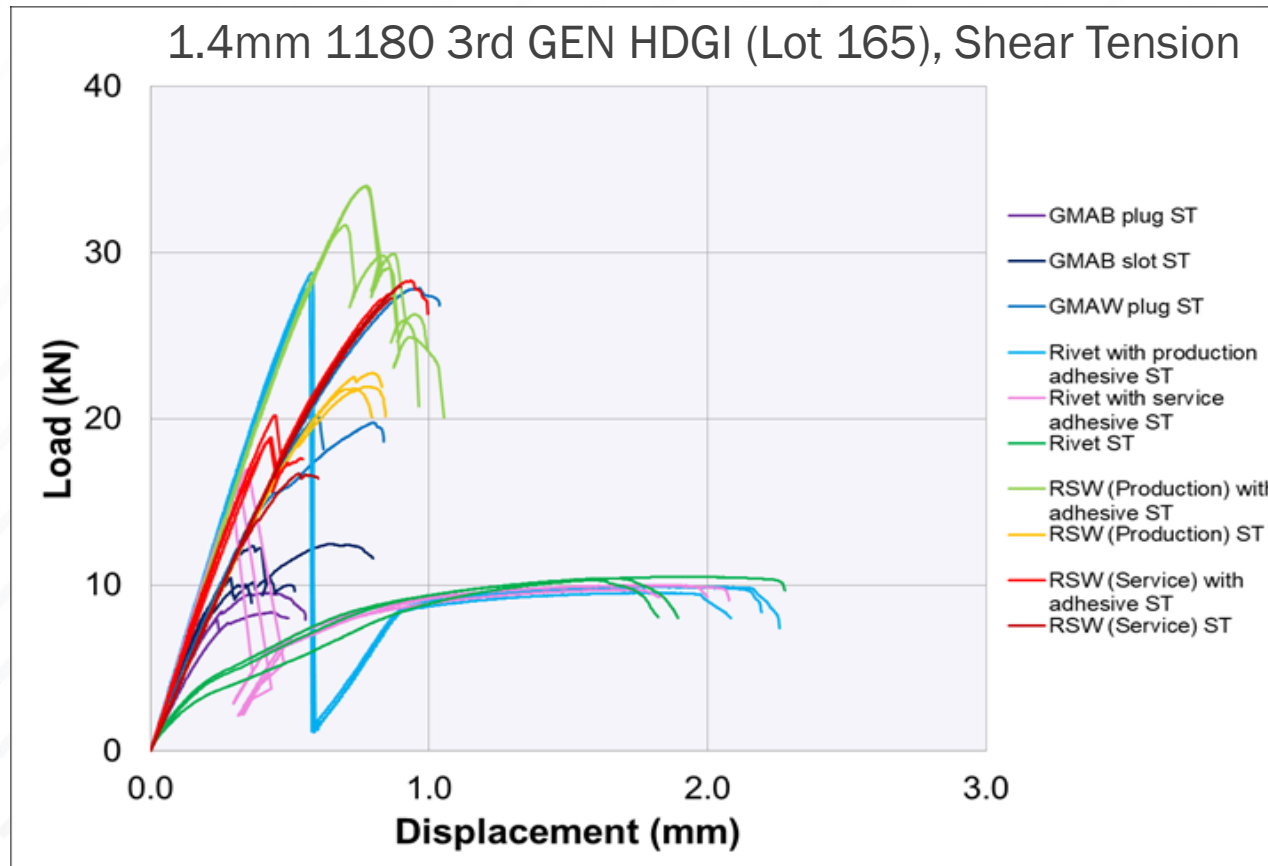
# PROJECT RESULTS | JOINT PEAK LOAD DISPLACEMENT PLOTS

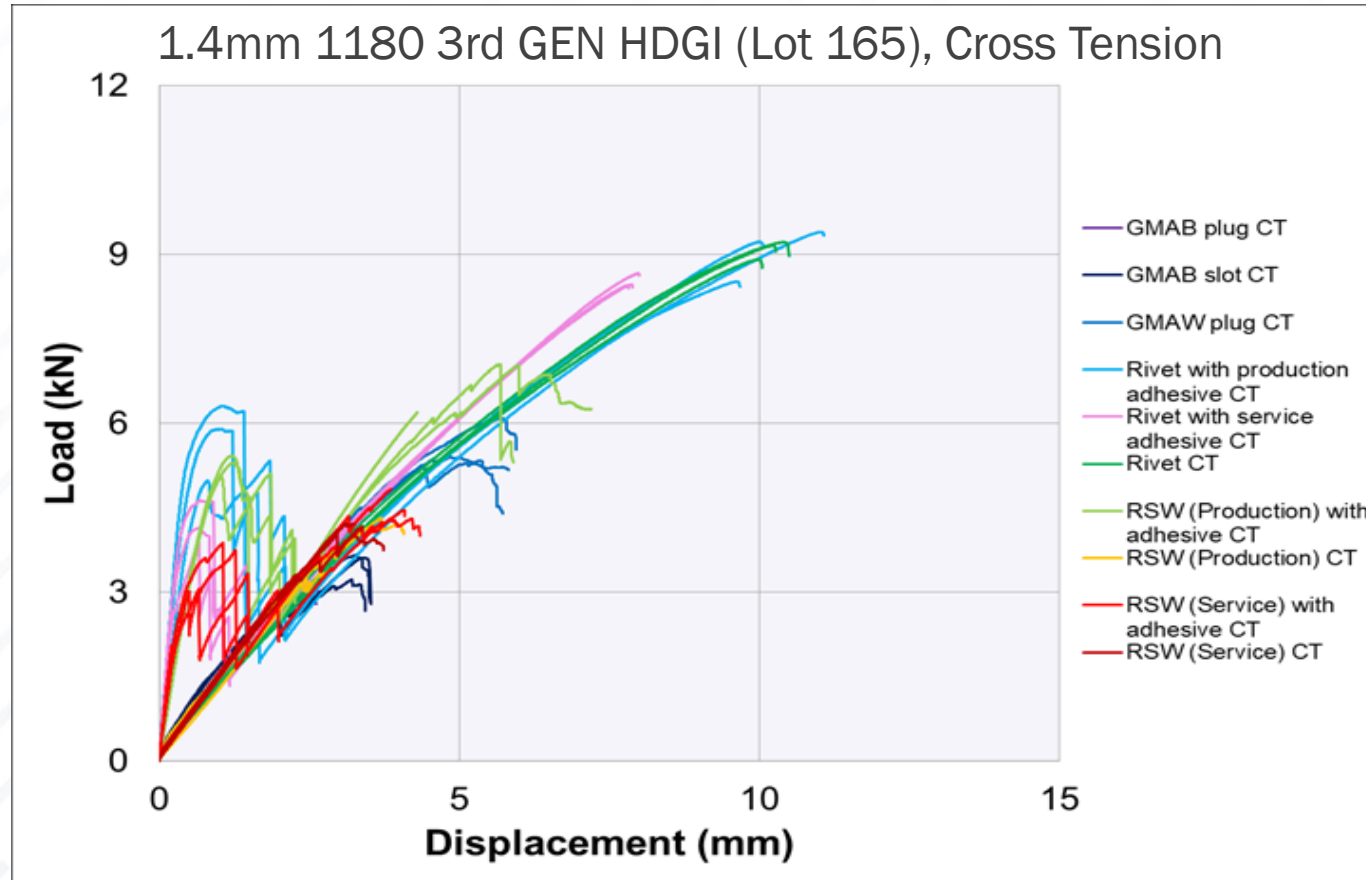
# PROJECT RESULTS | JOINT PEAK LOAD DISPLACEMENT PLOTS

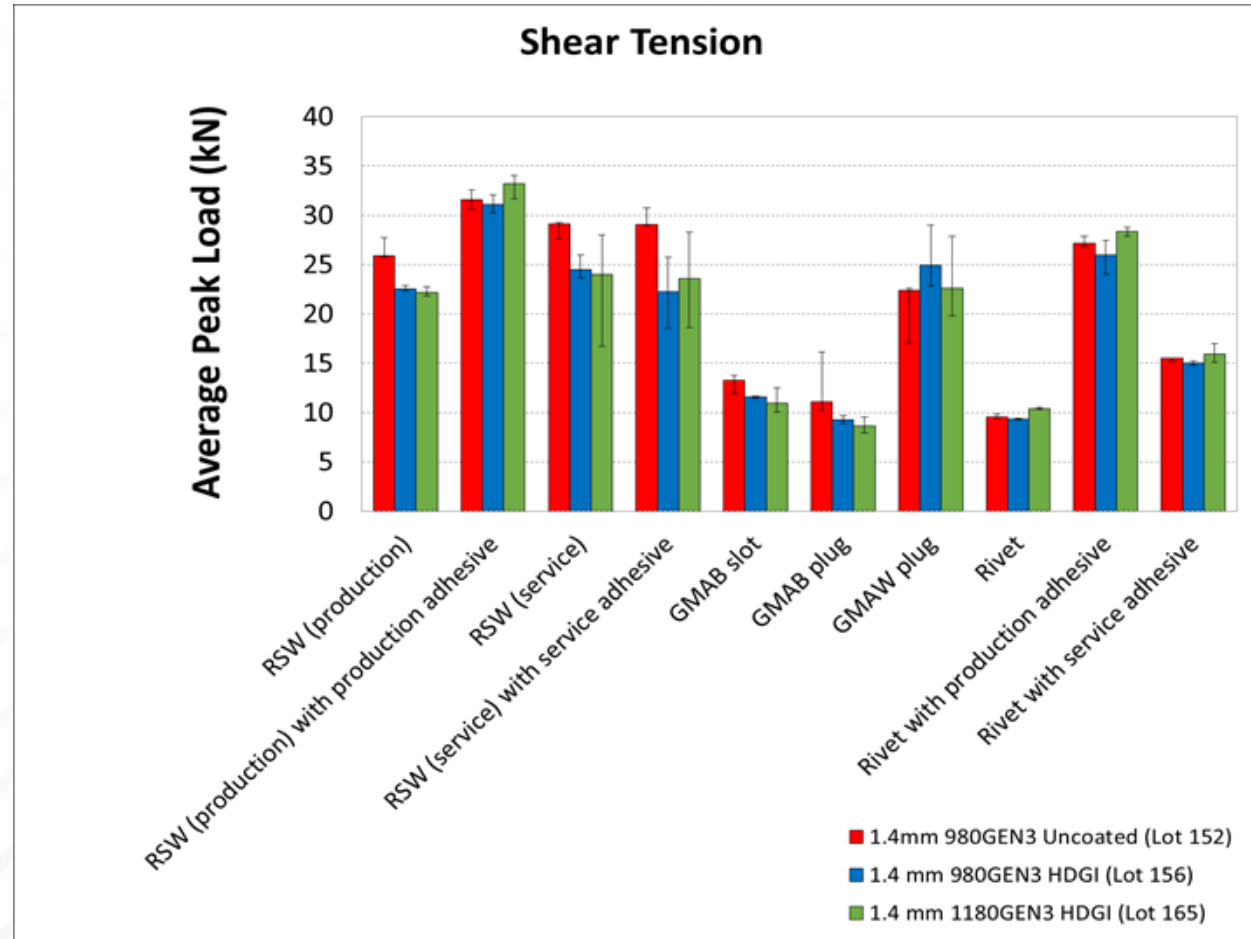
Shear Tension Comparison For All Types

Error bars indicate minimum and maximum peak loads for each group

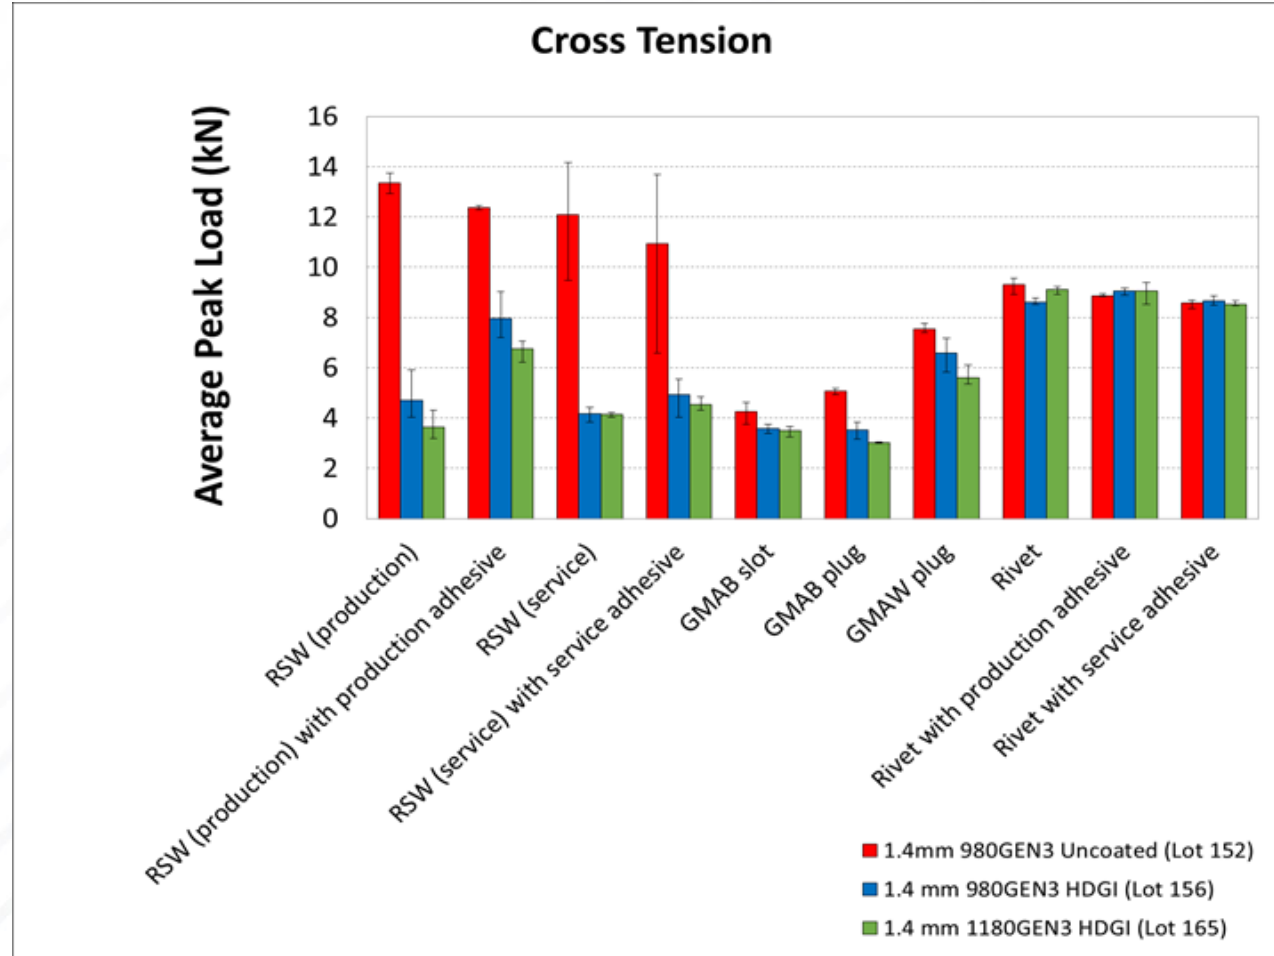
Cross Tension Comparison For All Types

Error bars indicate minimum and maximum peak loads for each group

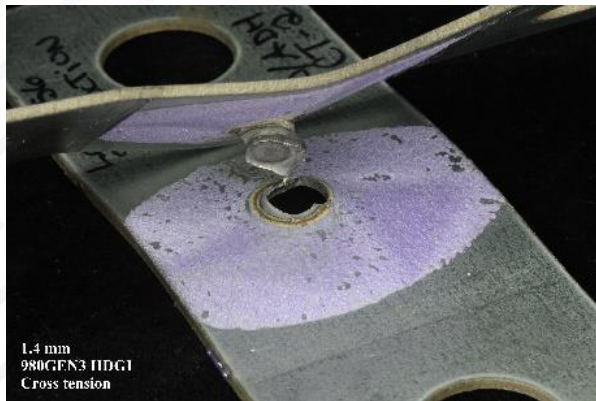
980 3rd GEN HDGI (Lot 156), CT

button pull – both sheets/cohesive separation

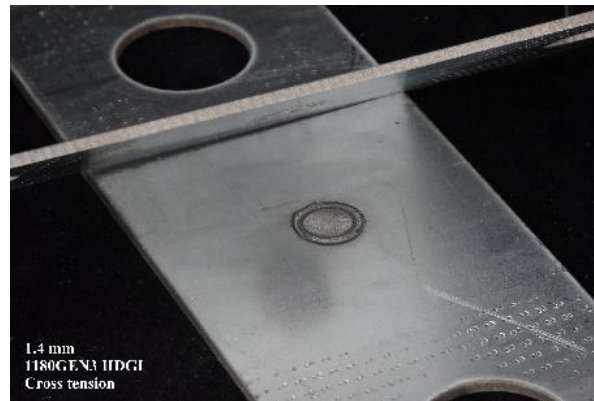
1180 3rd GEN HDGI (Lot 165), CT

interfacial

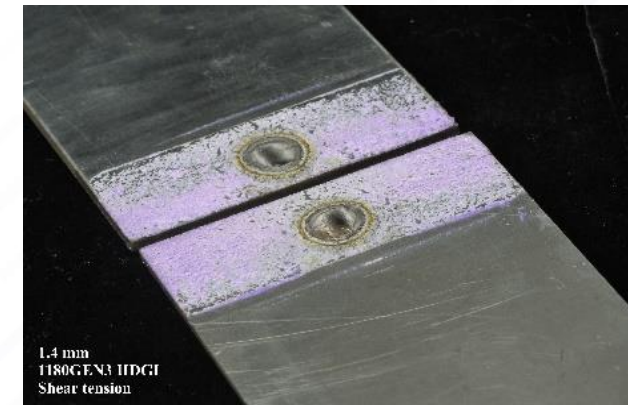
1180 3rd GEN HDGI (Lot 165), ST

interfacial/cohesive separation

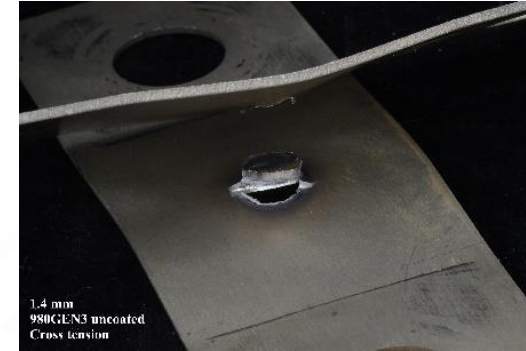
980 3rd GEN Uncoated (Lot 152), CT

weld pullout – both sheets

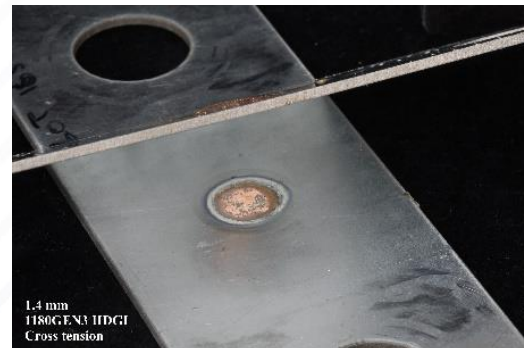
1180 3rd GEN HDGI (Lot 165), CT

braze fracture

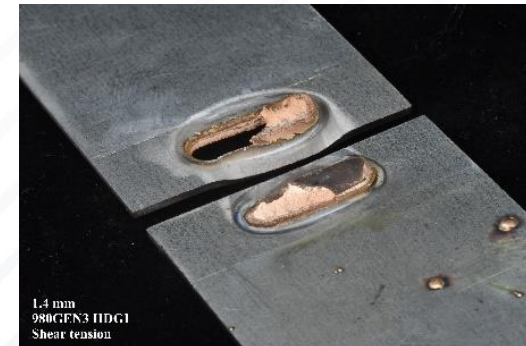
980 3rd GEN HDGI (Lot 156), ST

braze fracture/braze pullout – top sheet

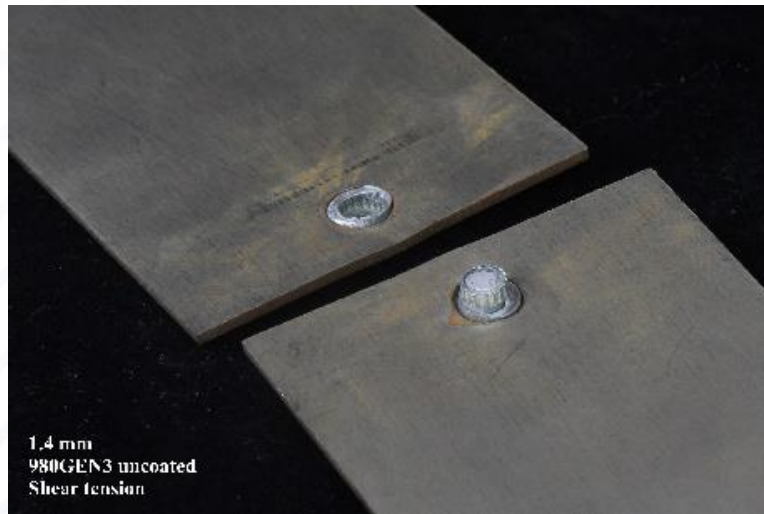
980 3rd GEN Uncoated (Lot 152), ST

rivet separation

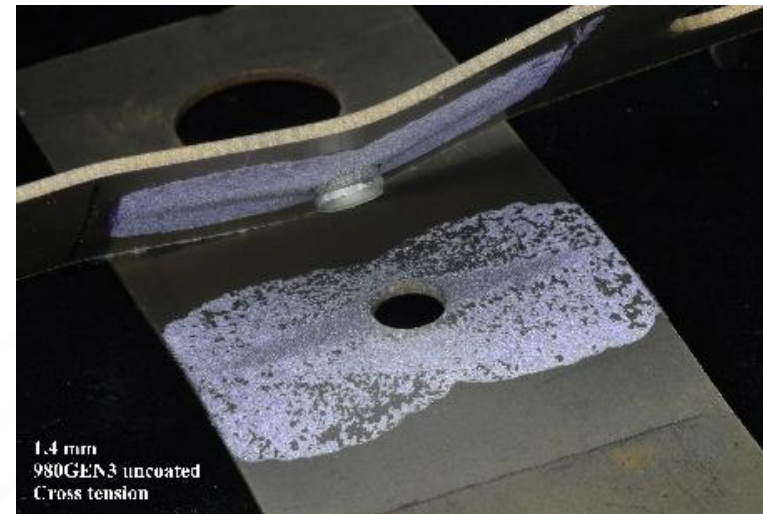
980 3rd GEN Uncoated (Lot 152), CT

rivet separation/cohesive separation
