**WELDABILITY INVESTIGATION OF  
3RD GEN AHSS FOR AUTOMOTIVE  
MANUFACTURING**

Kate Namola, M.S.

Toyota North America

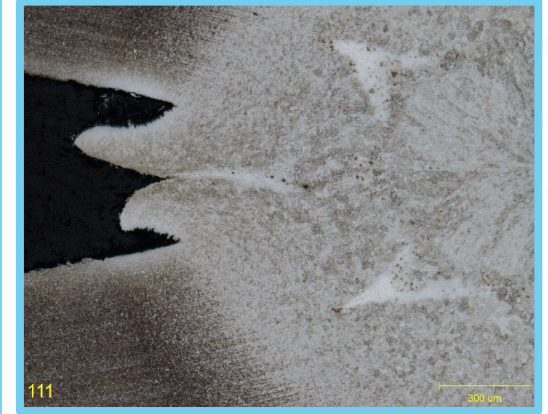
Re-filled Liquation Cracks Supplier Y Weld made with a 2-t Gap

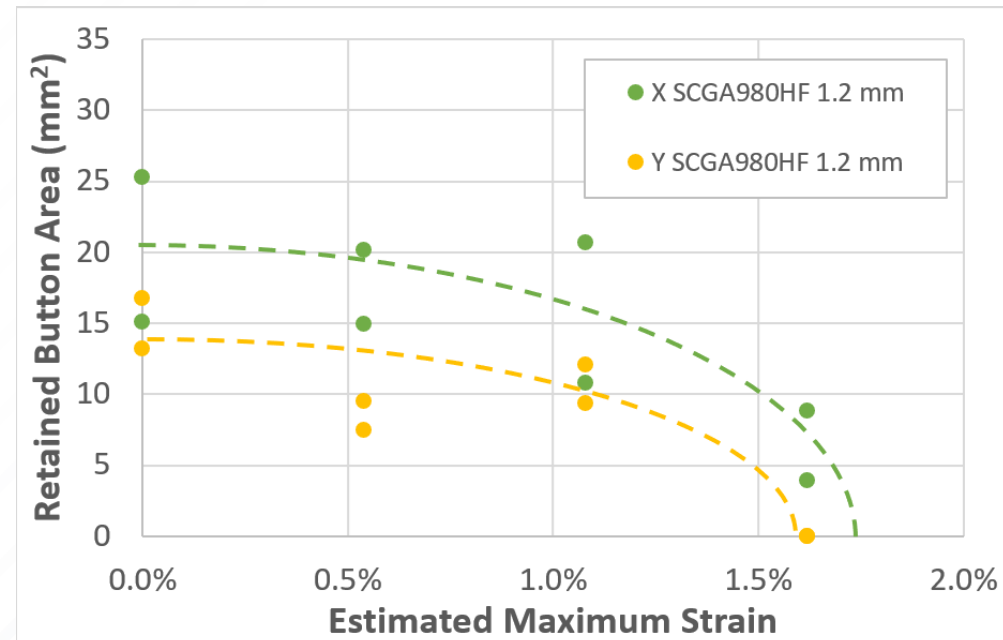
- Known to be variation in weldability of 3rd Gen AHSS
  - Prevalence of LME cracking
- Material provided by two top suppliers for weld evaluation
- Material performance characterized by plotting retained button area versus the maximum applied strain

- Materials were ranked against each other
- Galvannealed material found to be significantly less sensitive to LME cracking than galvanized
  - Alloying of the coating leaves less free zinc on the surface
- It is critical that chemistry of material supplied to manufacturing be tightly controlled to ensure quality

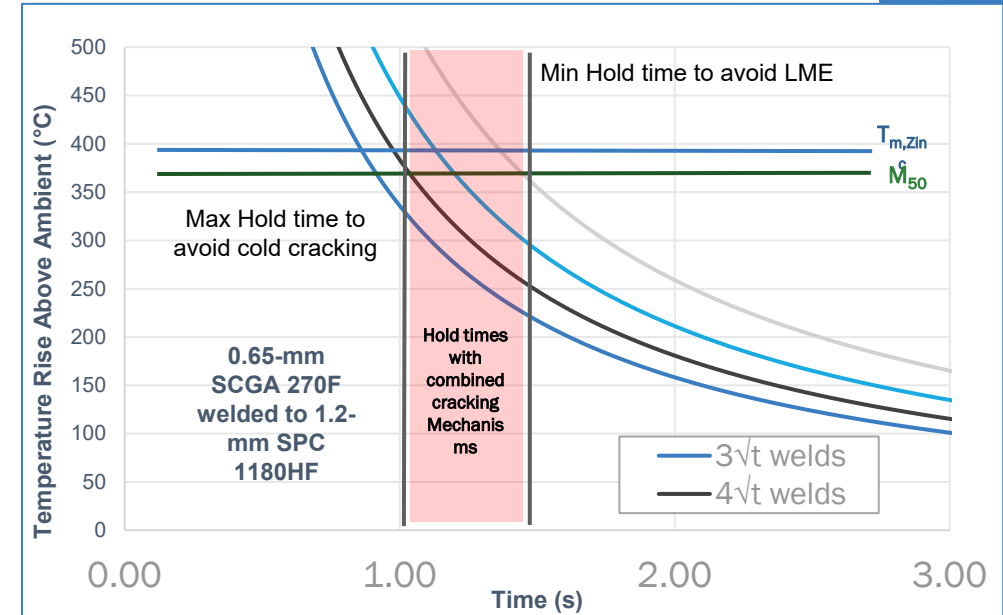
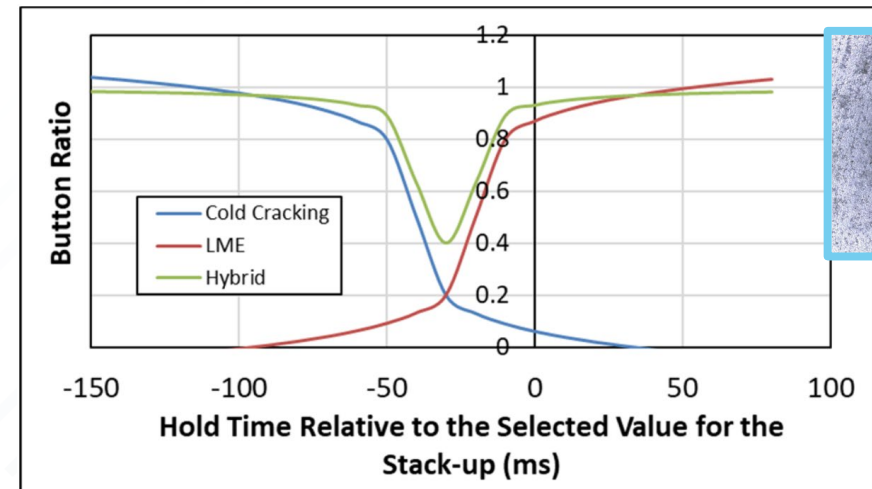
## Overlap of hold times for zinc solidus and M50 when considering all acceptable weld sizes

- Closeness of M50 temperature to zinc solidus (20-120C) caused overlap of necessary hold times for the two cracking mechanisms as weld size was varied from  $3\sqrt{t}$  to expulsion
- No hold time range could be established between the two conditions

## Long hold times favored to eliminate risk of both cracking mechanisms, but trough response also allows for the use of short hold times

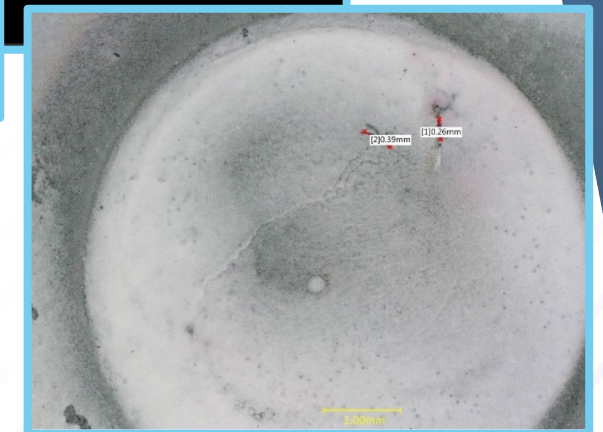
Final assessment of the weld stack-ups included and tensile shear, instrumented peel, die penetrant testing.

Computer tomography used on select samples to access weld porosity

Surface cracking occurred in 3 of 48 trials, and did not represent most welds made under a specific set of conditions

Welding under disturbed conditions only result in slight loss of joint strength

Shear strengths ranged from 4 to 20 times greater than peel strengths
