GREAT DESIGNS IN
STEEL

LASER WELDED COATING FREE PRESS HARDENED STEEL

Sarah Tedesco, Ming Shi, Jason Coryell, Jeff Wang and Zhou Wang

General Motors

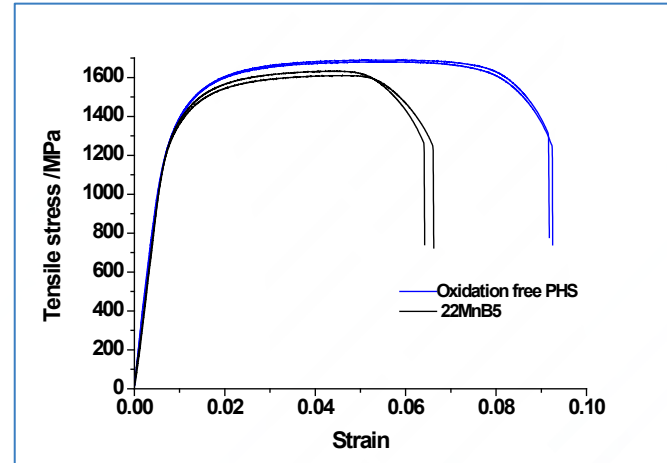
Uniaxial Tensile Testing

CFPHS (blue) has better elongation and higher tensile strength than current PHS

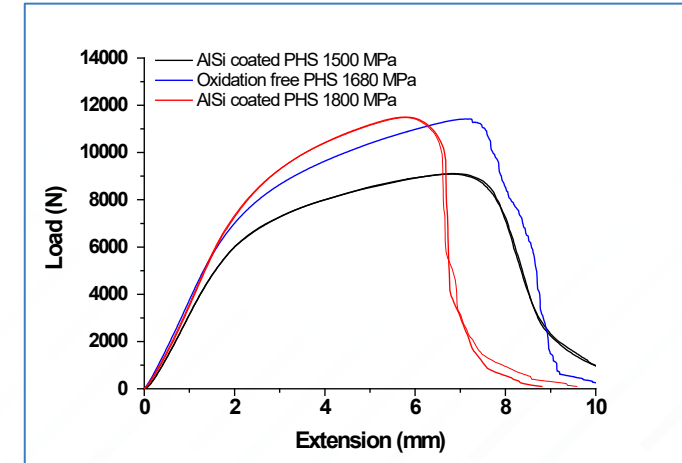
Component 3pt Bend Testing

CFPHS (blue) has higher peak load and longer extension than 2 grades (1500MPa and 1800MPa) PHS

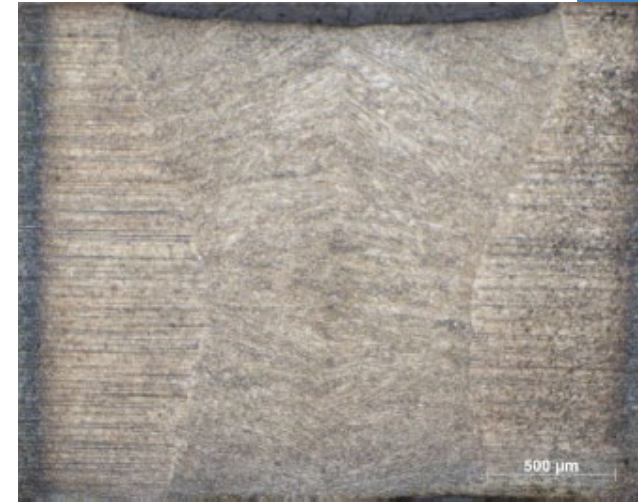
As Welded

- Initial phase of this project included welding 1.9mm CFPHS to 1.9mm CFPHS.
- Laser welding was done without ablation or filler wire
 - Ablation and filler wire not necessary as there is no AlSi coating to pollute the weld
- Laser welding accomplished with minimal effects to the microstructure.
 - A refined martensitic microstructure in the weld zone was visible in the as welded sample
 - The final press hardened sample showed little difference between the base material and the weld zone

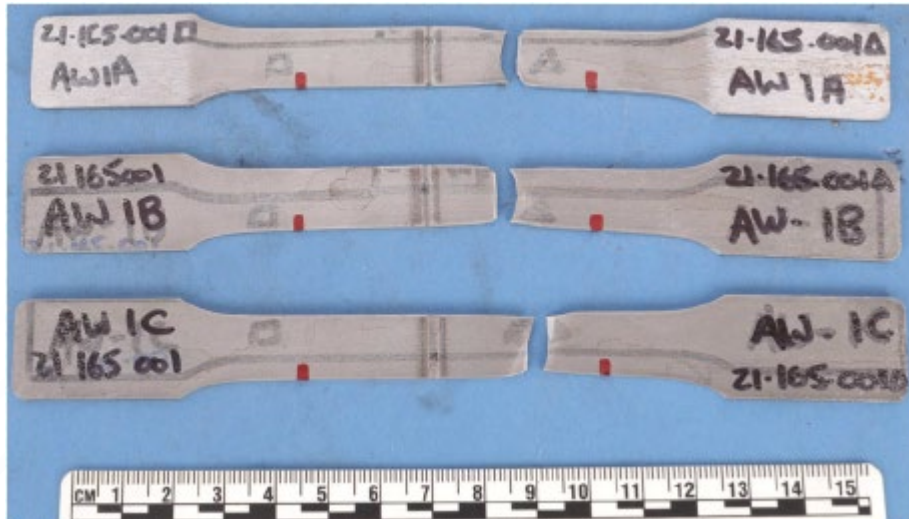
- Results showed fracture in the parent metal to the side of the weld, as expected.
- Since the weld area is harder compared to the parent metal as welded, the material fractures in the parent metal.
- The extra strength of the as welded material can be attributed the resistance added by the strengthened weld.

Sample	Yield Strength (MPa)	Tensile Strength (MPa)	Total Elongation (%)
1	904	1399	8.9
2	901	1403	8.5
3	903	1399	8.7
Avg.	903	1400	8.7

Sample	Yield Strength (MPa)	Tensile Strength (MPa)	Total Elongation (%)
1	1064	1413	9.5
2	1040	1382	9.0
3	983	1294	8.4
Avg.	1029	1363	9.0

- Press hardened weld seams showed uniform martensitic microstructure with equalized hardness across the weld zone (microhardness map)
- Tensile specimens of the as-welded showed parent metal fracture

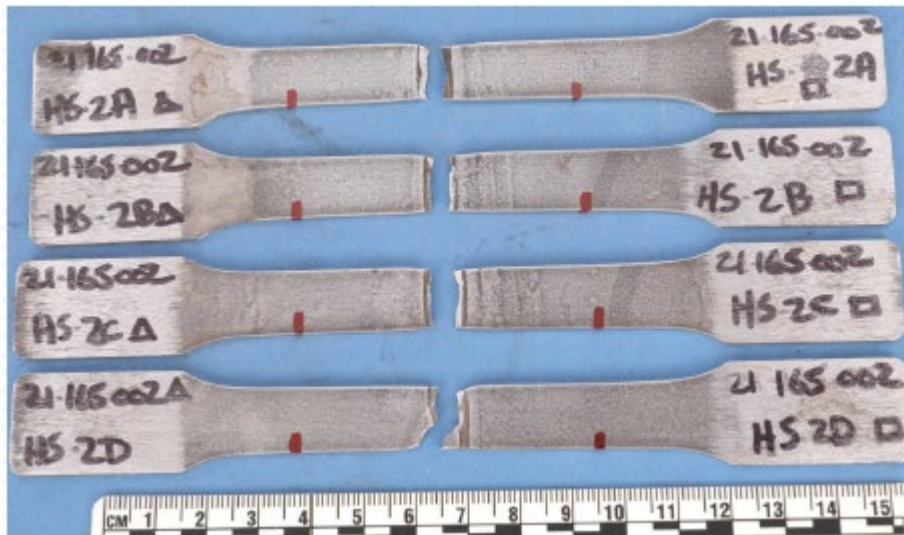
- Results showed the parent and welded samples are comparable in strength.
- The weld zone fractured in part due to geometrical factors of the weld being slightly thinner than the parent material

Sample	Yield Strength (MPa)	Tensile Strength (MPa)	Total Elongation (%)
1	1020	1597	8.2
2	1049	1629	8.1
3	1083	1656	7.2
Avg.	1051	1627	7.8

Sample	Yield Strength (MPa)	Tensile Strength (MPa)	Total Elongation (%)
1	1243	1626	5.5
2	1245	1631	4.9
3	1245	1636	5.3
4	1205	1599	6.5
Avg.	1235	1623	5.6

- Heat treated samples showed fractures in the weld seam due to small geometric thickness variation within the weld seam
- DIC was used to quantify and localize the stresses within the weld sample. DIC samples showed variation in the location of fracture

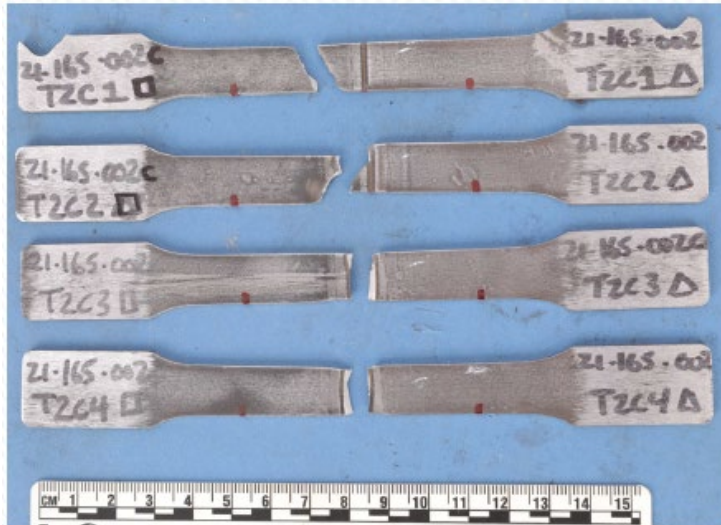
Results showed fractures in parent metal and the weld zone. Typical tensile failure was seen in 3 samples. Tensile results were comparable to parent material.

Sample	Yield Strength (MPa)	Tensile Strength (MPa)	Total Elongation (%)
1	1056	1610	6.1
2	1099	1644	5.3
3	1116	1610	5.0
4	1075	1590	5.4
Avg.	1087	1614	5.5

- Fracture occurred in the parent metal in one instance
 - Primarily fracture occurred in the weld seam.
- DIC results correlated well with the standard testing results. All correlated back to the parent material results. Strength of material not adversely impacted by the welding process post heat treatment.

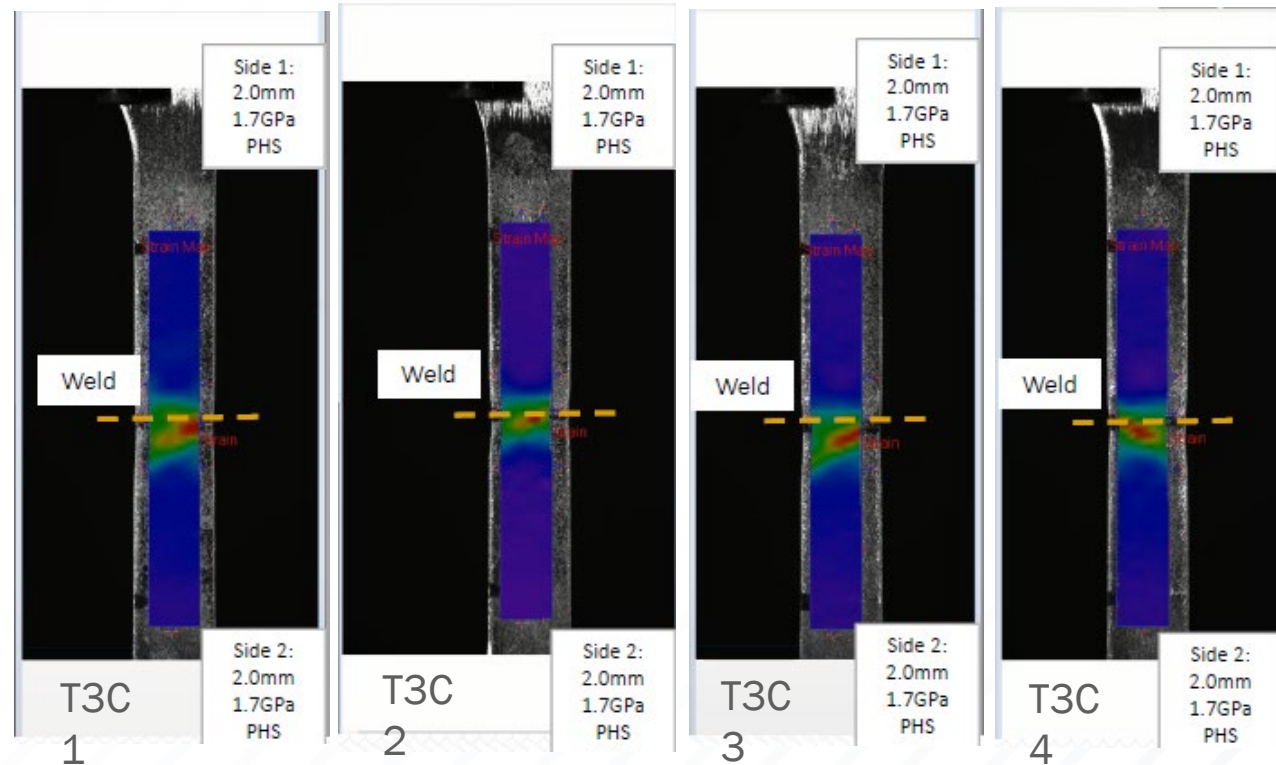
Results showed fractures in the weld zone for all 4 samples. Tensile results were comparable to parent material.

Sample	Yield Strength (MPa)	Tensile Strength (MPa)	Total Elongation (%)
1	1134	1567	5.0
2	1180	1579	4.5
3	1171	1577	4.9
4	1139	1555	5.4
Avg.	1156	1570	4.9

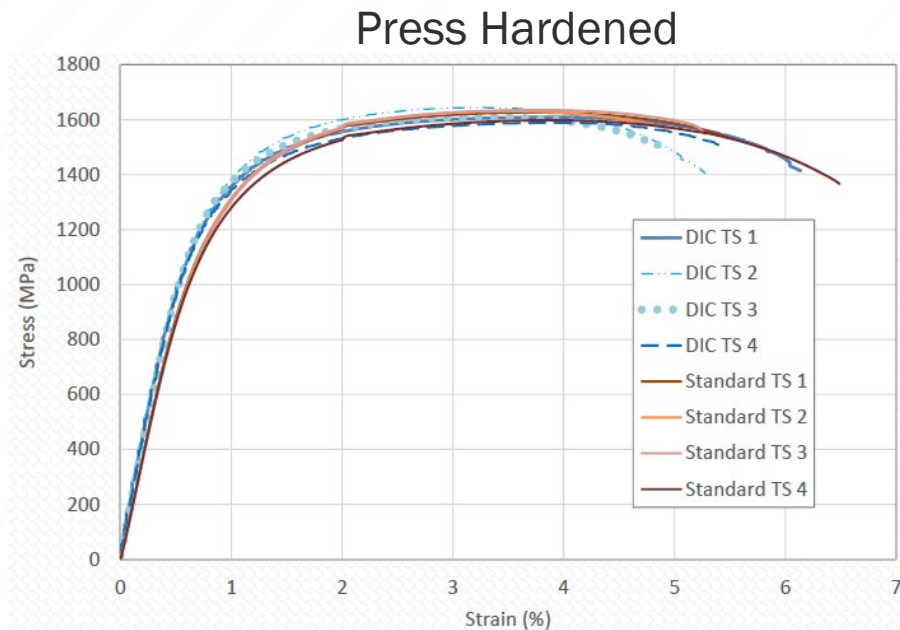
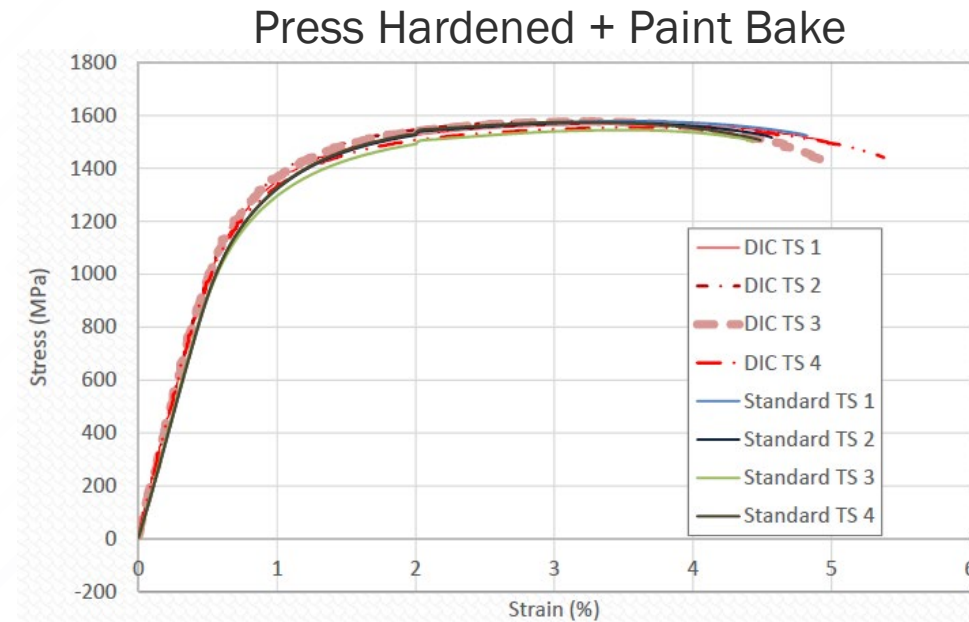
- Both sets of results showed comparable results to between the two tests
- Both tests resulted in curves typical of parent metal in both conditions

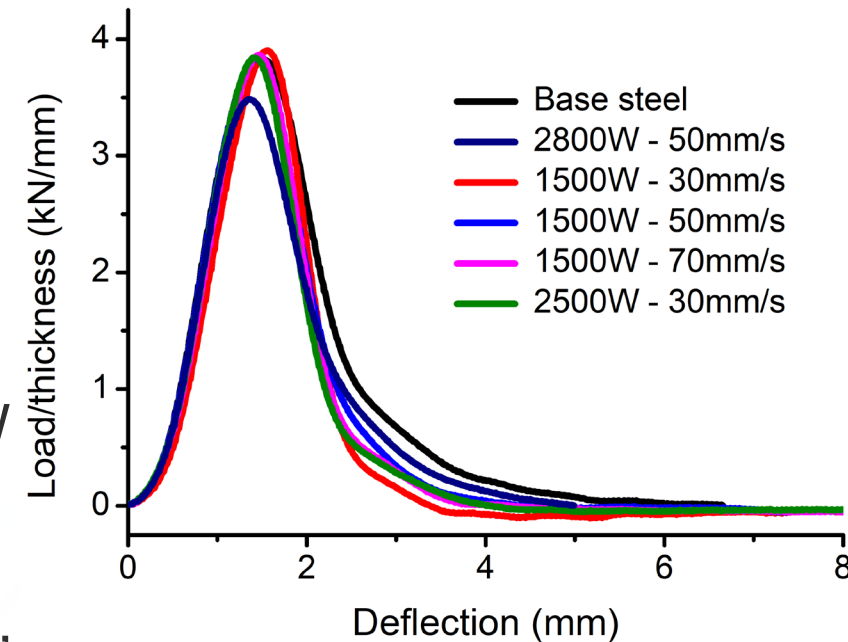
- Samples were welded with various energy inputs ranging from 1500W to 2800W with Ar shielding gas
- Samples were ground at the weld seam prior to impact testing to eliminate variability from any surface imperfections
- Samples were tested for load deflection at various head speeds. Speeds varied from 30mm/s to 70mm/s
- 1500W samples were comparable to the 2500W samples. Both absorbed more impact energy than the 2800W samples.
- The 2800W sample weld seam contained pores, affecting the results

Weld Energy	30 mm/s	50 mm/s	70 mm/s
1500 W	$61.7 \pm 4.4 \text{ J cm}^{-2}$	$65.8 \pm 0.0 \text{ J cm}^{-2}$	$63 \pm 3.4 \text{ J cm}^{-2}$
2500 W	$63.7 \pm 5.2 \text{ J cm}^{-2}$	On the way	On the way
Base steel	$76.1 \pm 6.2 \text{ J cm}^{-2}$

Results showing energy absorbed by various samples and head speeds.

- 1500W laser power was sufficient to achieve optimal impact testing energy absorption
- Conclusions: laser welding of CFPHS to CFPHS shows good promise for future applications in terms of weld seam uniformity and integrity of weld seam in crash situations
